*Worldwide repairs carried out with PolymerMetal®*

**REP-# 109**

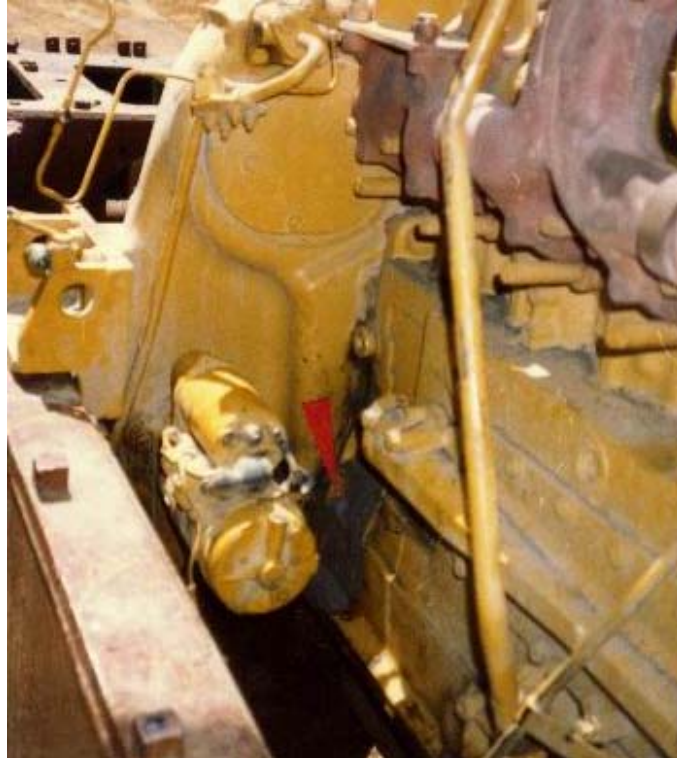
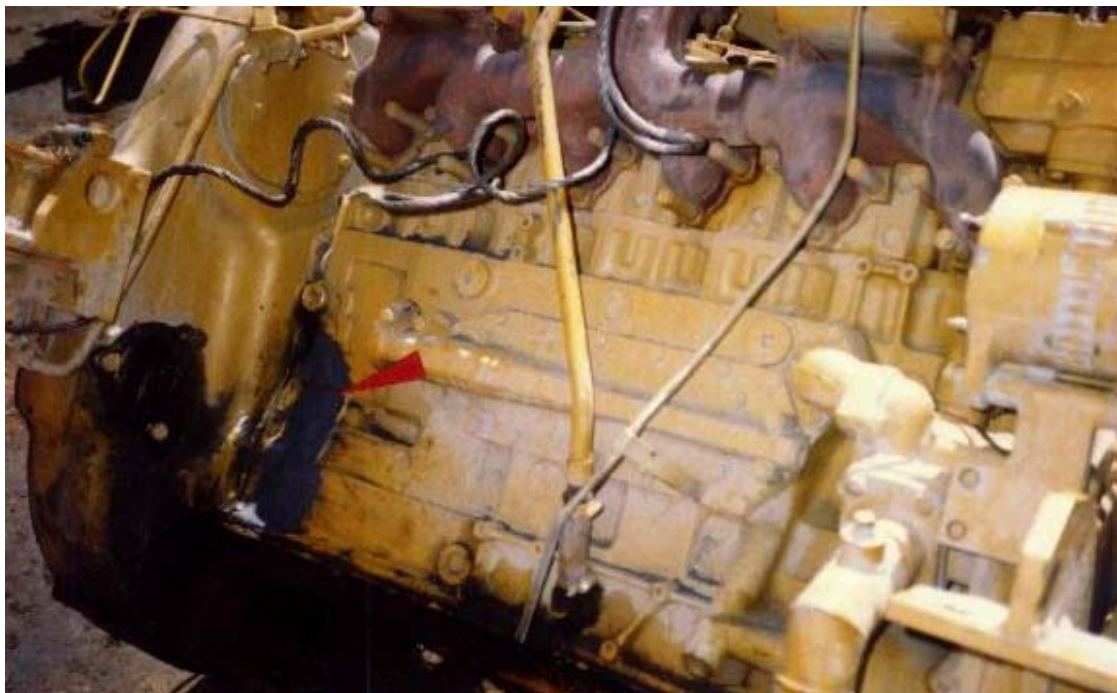
Repair of a hair crack at a main engine block of a bulldozer (make Komatsu). The hair crack was appr. 20 inches long. A first attempt to repair by electro welding failed. Then the engine block was successfully restored by using the direct-MM-bonding method with MM-metal oL-steelceramic.
