*Worldwide repairs carried out with PolymerMetal®*

**REP-# 089**

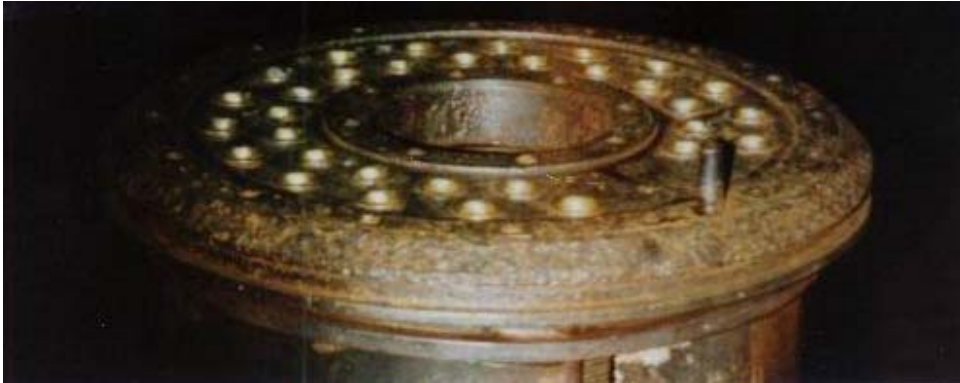
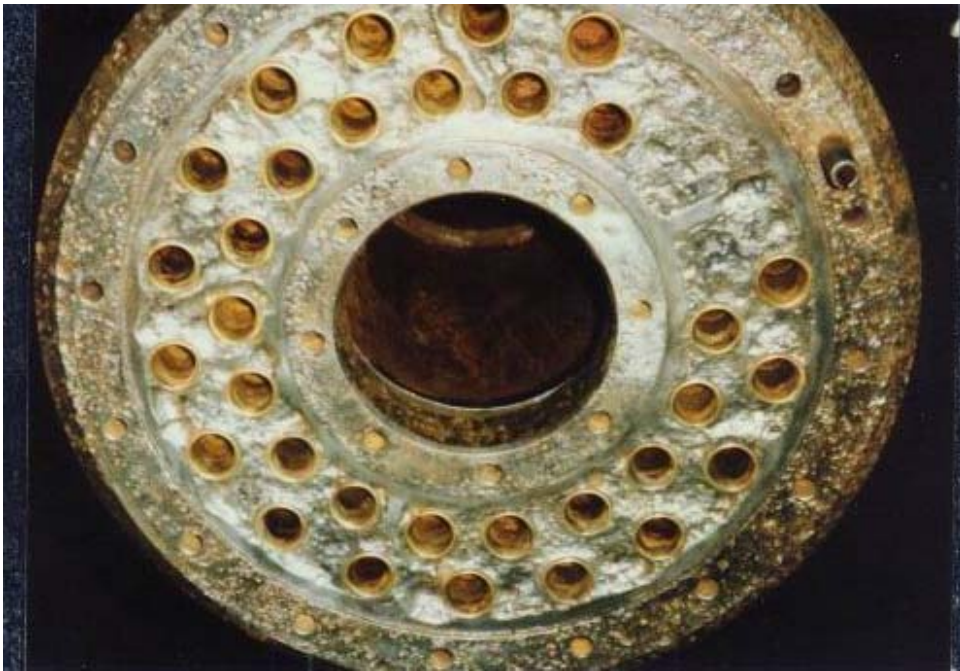
Repair of the soot blower compressor at a heat station by coating the additional cooler with Ceramium. The coating was affected in two steps: a first application of Ceramium pasty type, afterwards a second application with Ceramium liquid type.
